## Section 2.2 Site Investigation Reports

### 2.2.6.1 Drainage CCTV Report

**Project Name:** Poyle- Horton Road  
**Project Description:** WinCan Import in Miraculix Standard  
**Project Date:** 07/03/2024

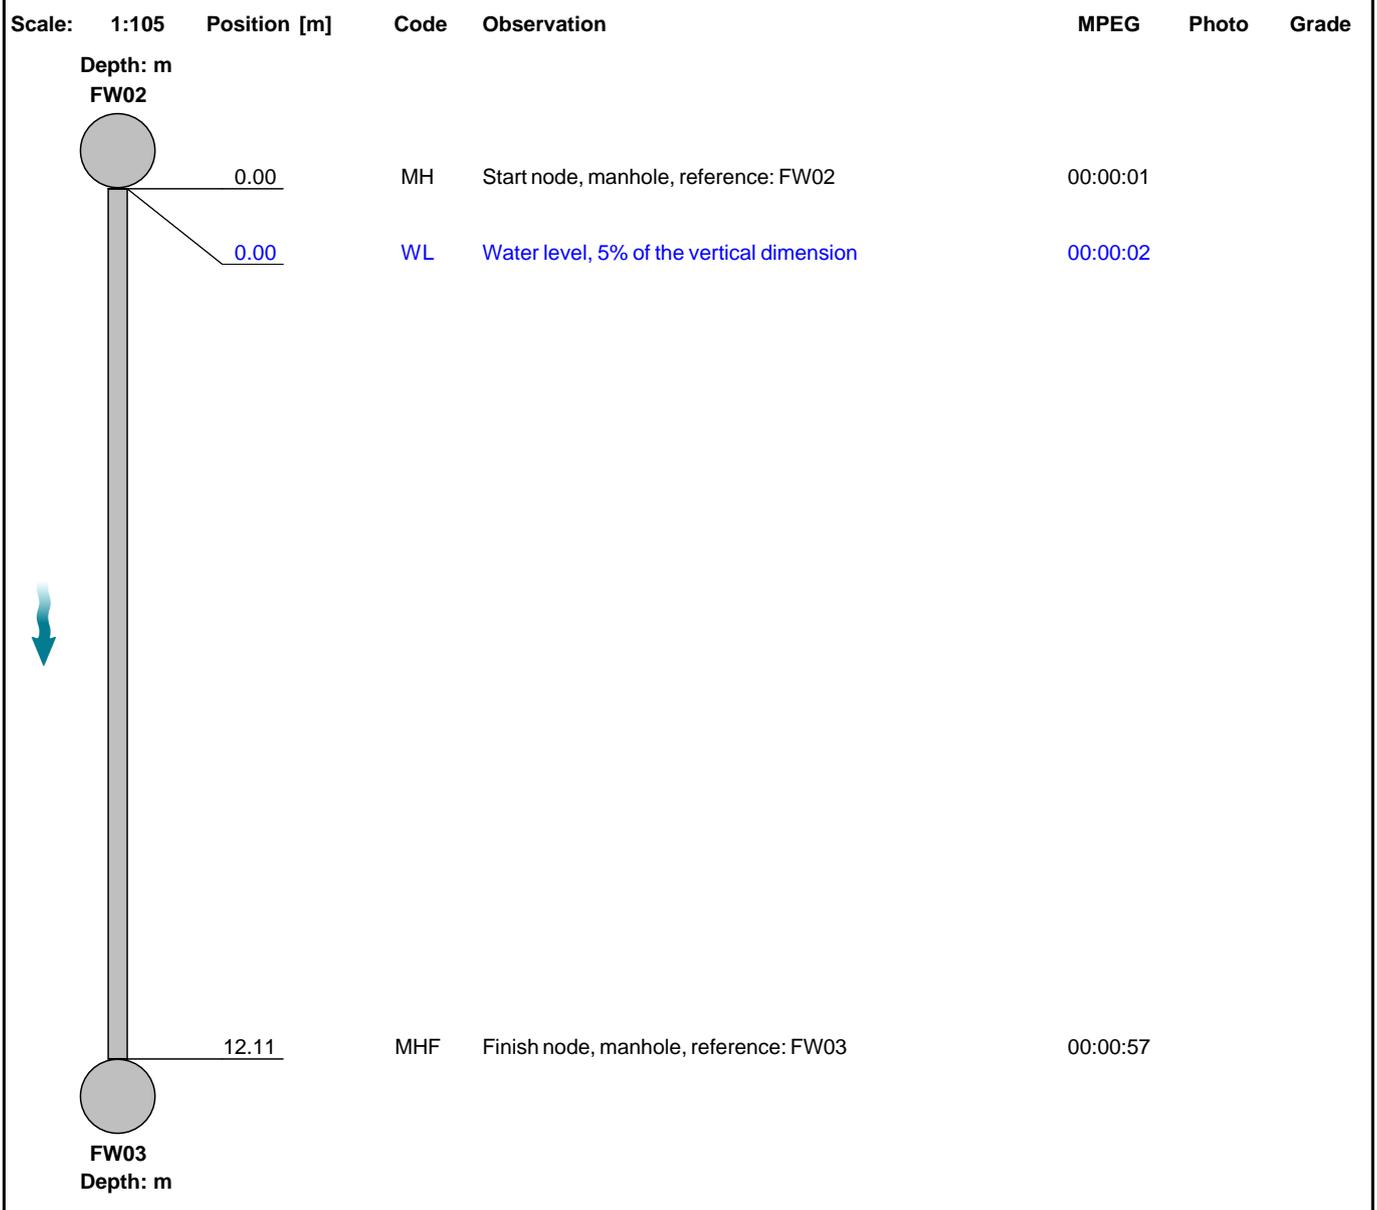
## Section Inspection - 20/11/2023 - FW02X

Construction Features					Miscellaneous Features				
Structural Defects					Service & Operational Observations				
STR No. Def	STR Peak	STR Mean	STR Total	STR Grade	SER No. Def	SER Peak	SER Mean	SER Total	SER Grade
0	0.0	0.0	0.0	0.0	0	0.0	0.0	0.0	0.0

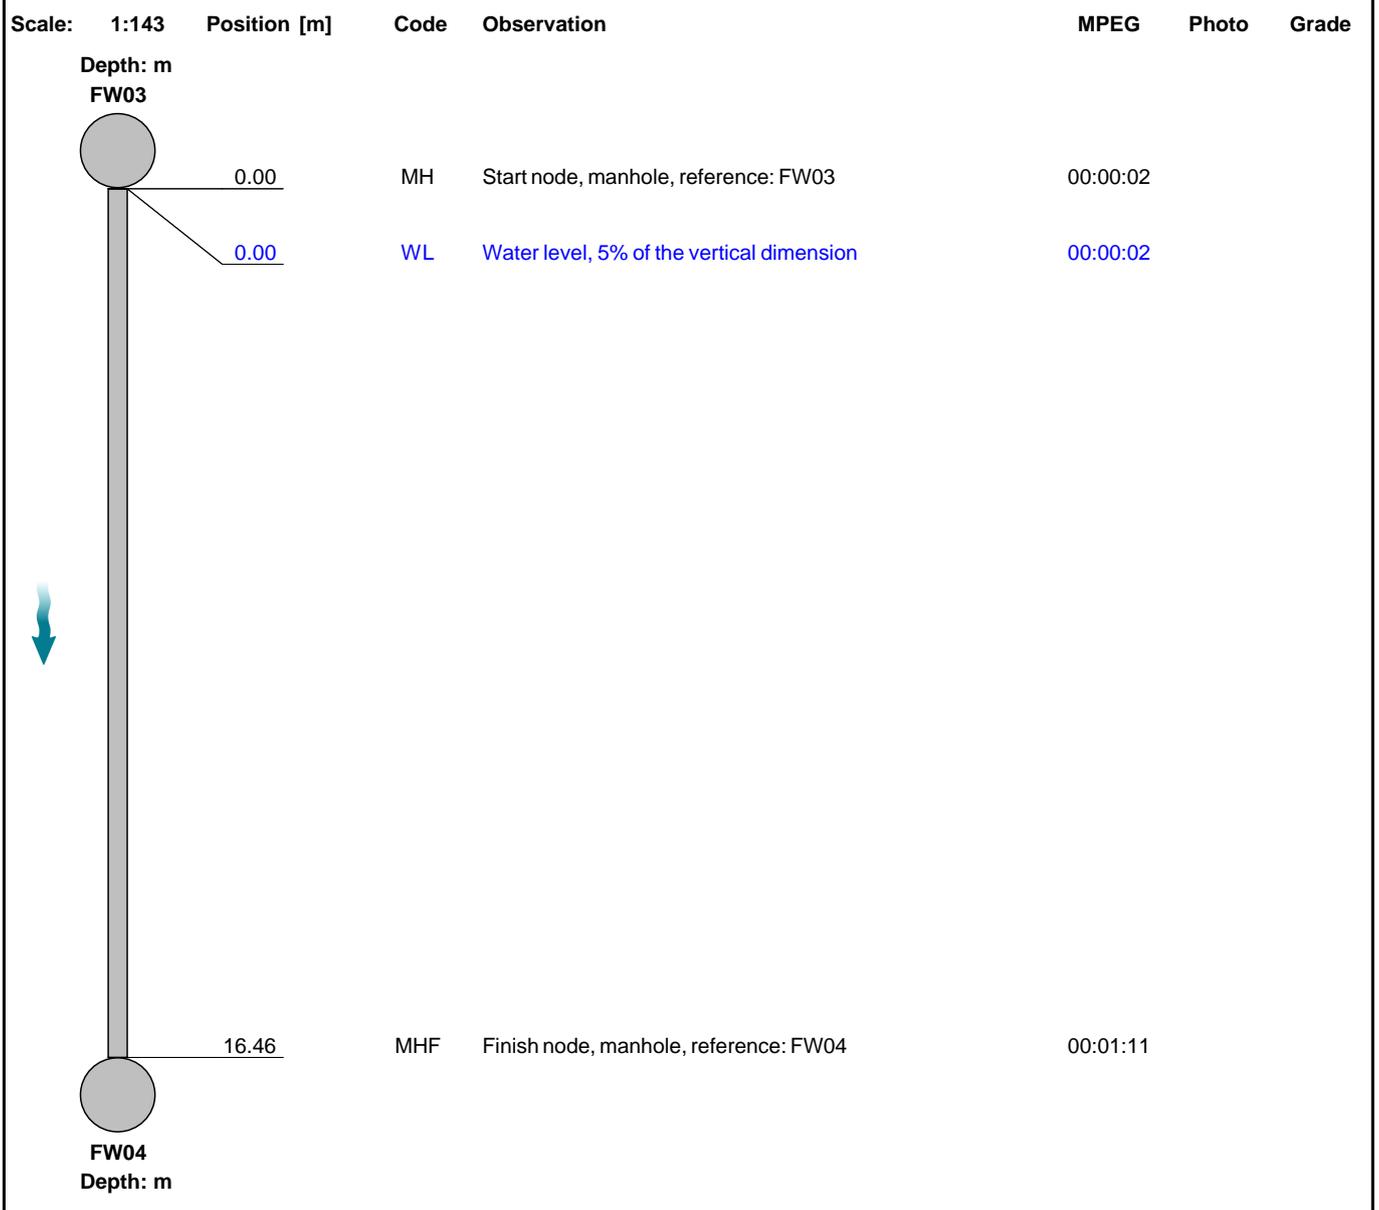
## Section Inspection - 20/11/2023 - FW03X

Construction Features					Miscellaneous Features				
Structural Defects					Service & Operational Observations				
STR No. Def	STR Peak	STR Mean	STR Total	STR Grade	SER No. Def	SER Peak	SER Mean	SER Total	SER Grade
0	0.0	0.0	0.0	0.0	0	0.0	0.0	0.0	0.0

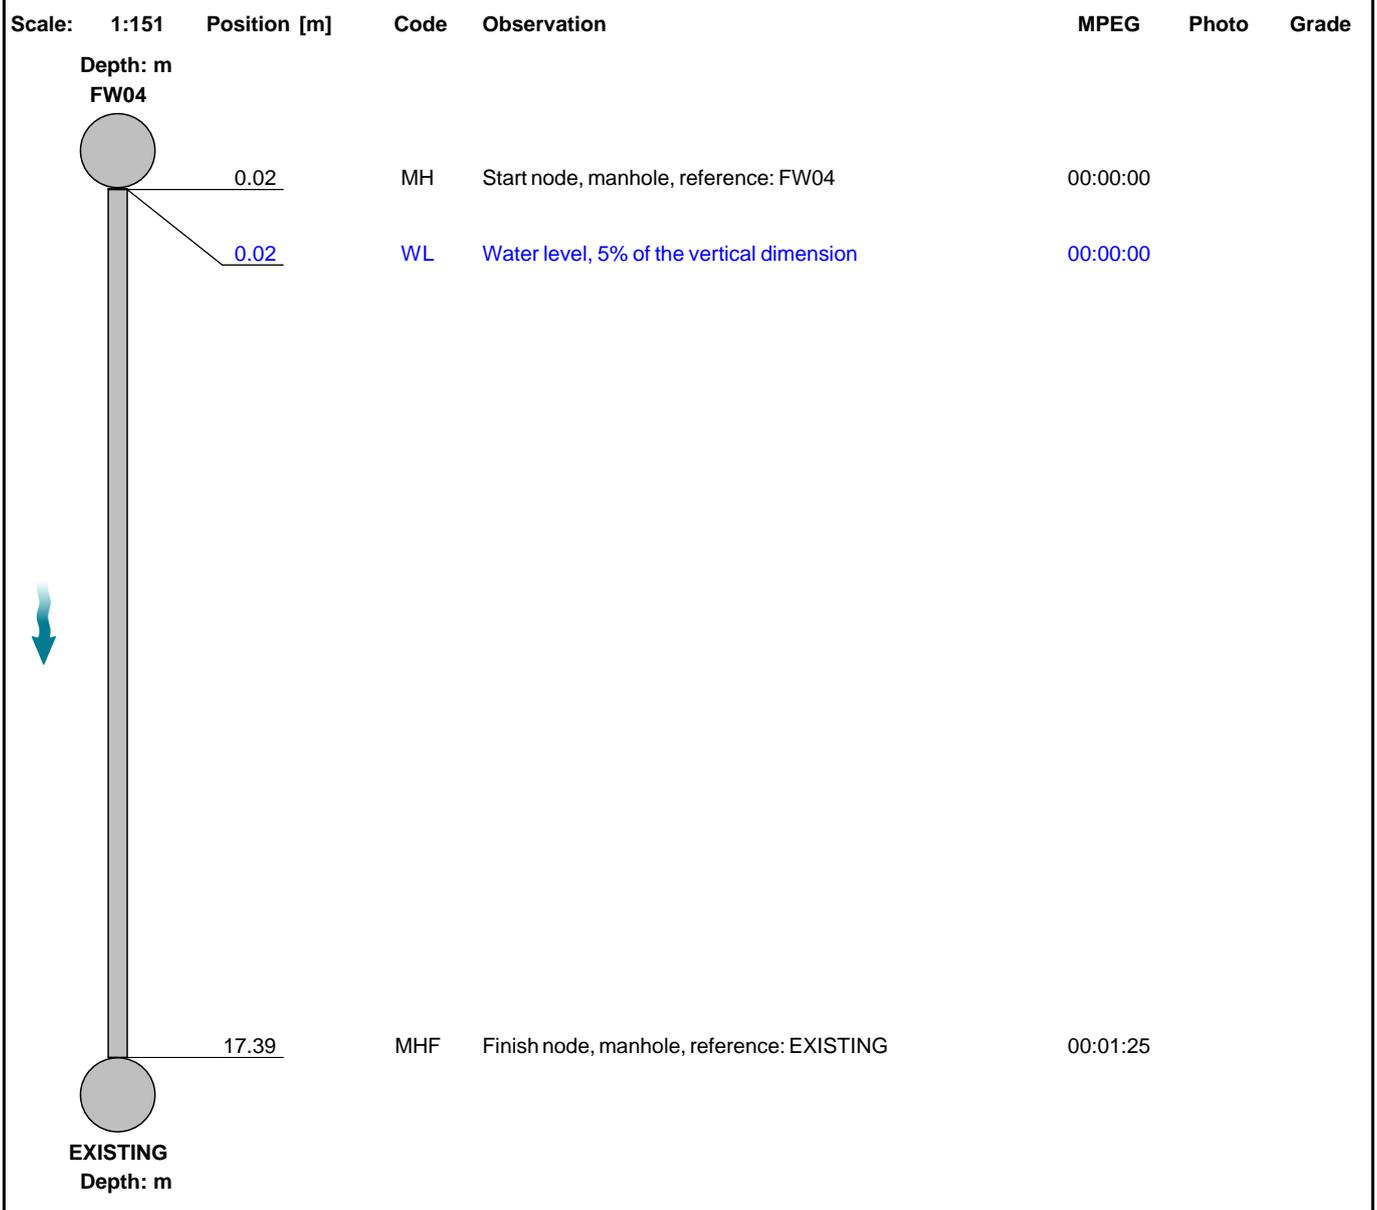
## Section Inspection - 20/11/2023 - FW04X

Construction Features					Miscellaneous Features				
Structural Defects					Service & Operational Observations				
STR No. Def	STR Peak	STR Mean	STR Total	STR Grade	SER No. Def	SER Peak	SER Mean	SER Total	SER Grade
0	0.0	0.0	0.0	0.0	0	0.0	0.0	0.0	0.0

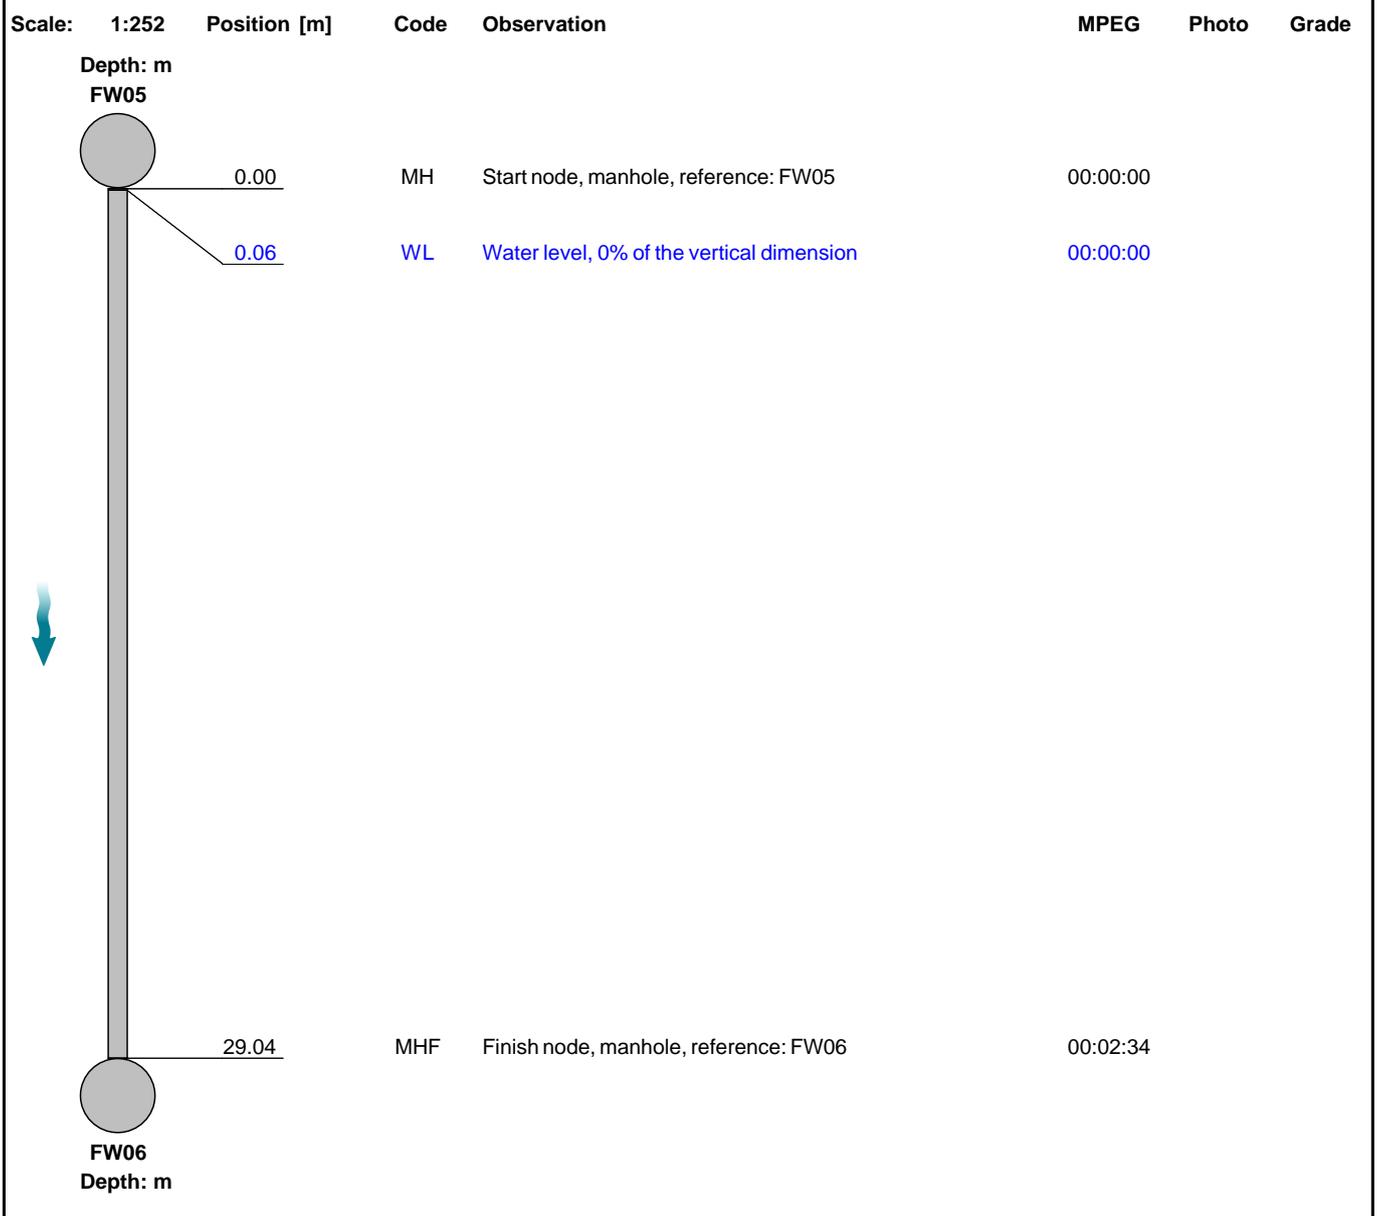
## Section Inspection - 20/11/2023 - FW05X

Construction Features					Miscellaneous Features				
Structural Defects					Service & Operational Observations				
STR No. Def	STR Peak	STR Mean	STR Total	STR Grade	SER No. Def	SER Peak	SER Mean	SER Total	SER Grade
0	0.0	0.0	0.0	0.0	0	0.0	0.0	0.0	0.0

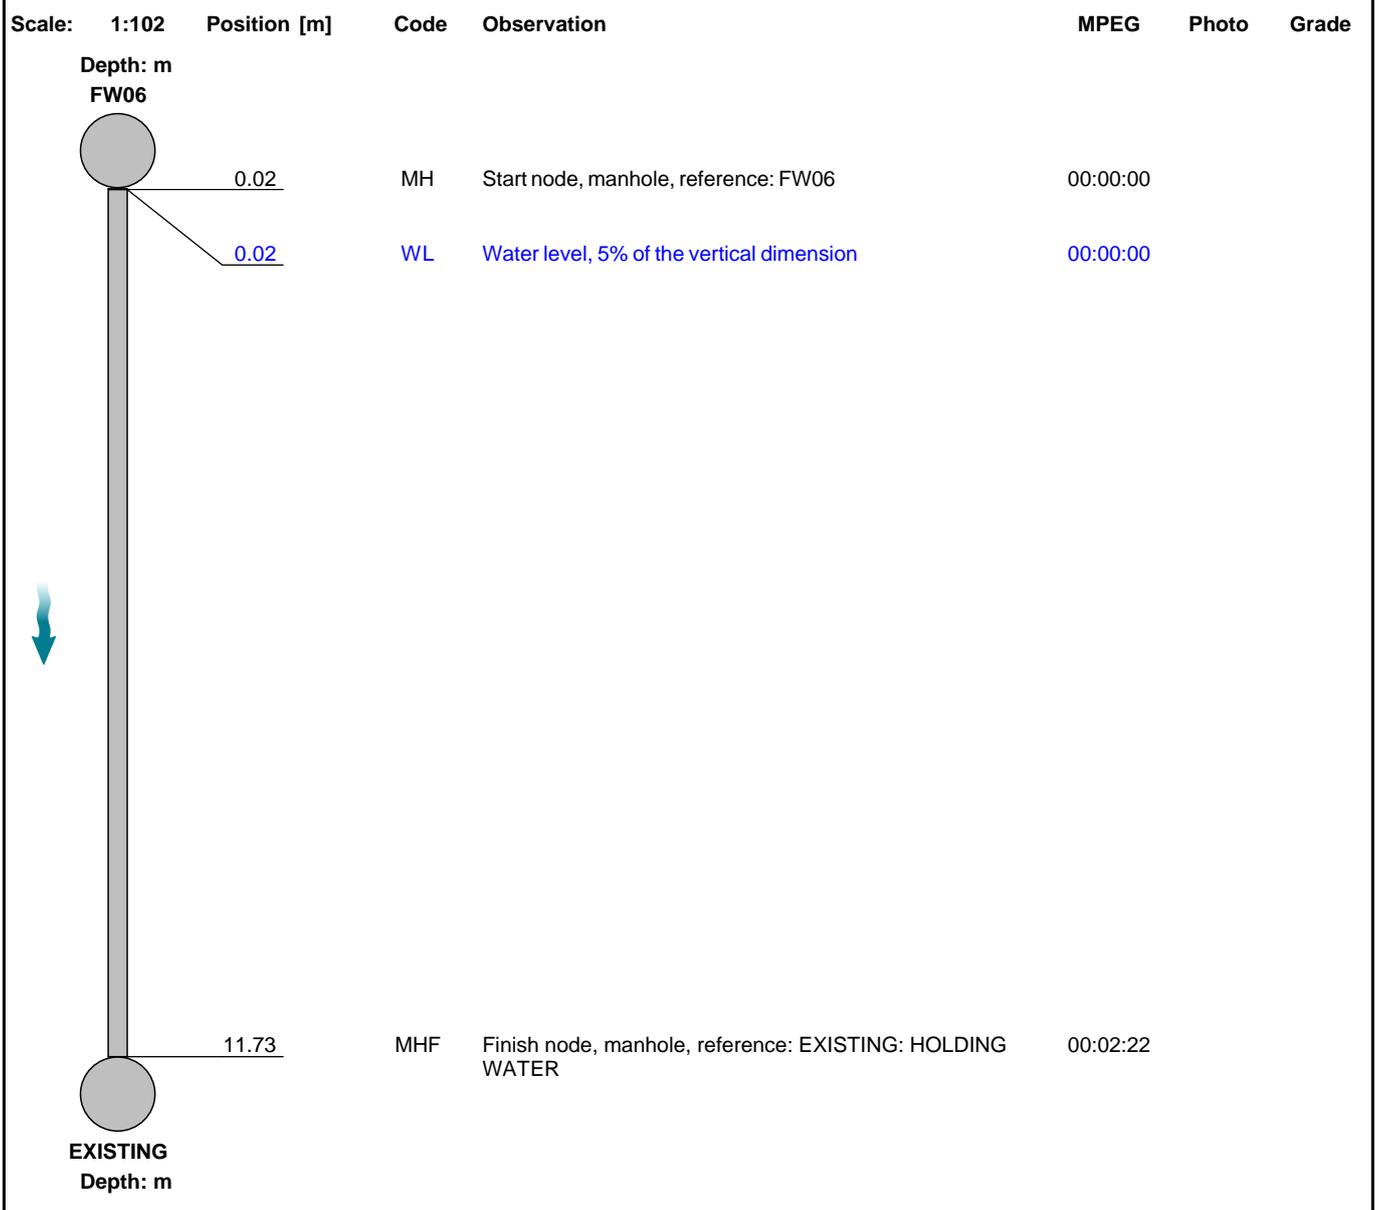
## Section Inspection - 20/11/2023 - FW06X

Construction Features					Miscellaneous Features				
Structural Defects					Service & Operational Observations				
STR No. Def	STR Peak	STR Mean	STR Total	STR Grade	SER No. Def	SER Peak	SER Mean	SER Total	SER Grade
0	0.0	0.0	0.0	0.0	0	0.0	0.0	0.0	0.0
